**Flood Control Project Maintenance  
Levee Inspections****LMA District Cover Sheet****Spring 2013 Levee Inspection Results****Reclamation District No. 2095 Paradise Cut**

**Levee Inspection Report By Mile - Spring 2013**

**Reclamation District No. 2095 Paradise Cut**

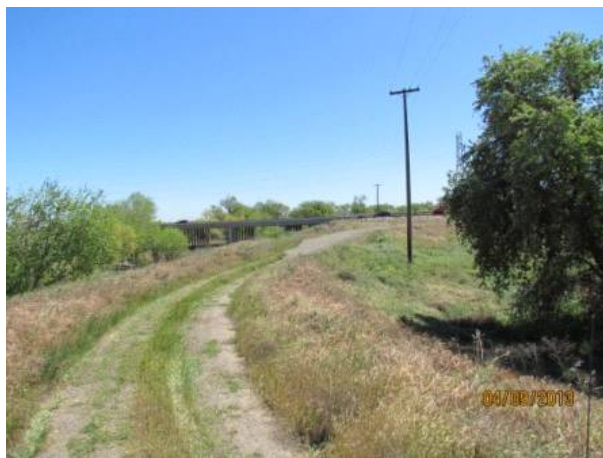
Levee Mile Report Line	5
Start Levee Mile	0.05
End Levee Mile	0.11
Location	Land Side
Category	
Item	Vegetation

View of the vegetation on landside levee slope.

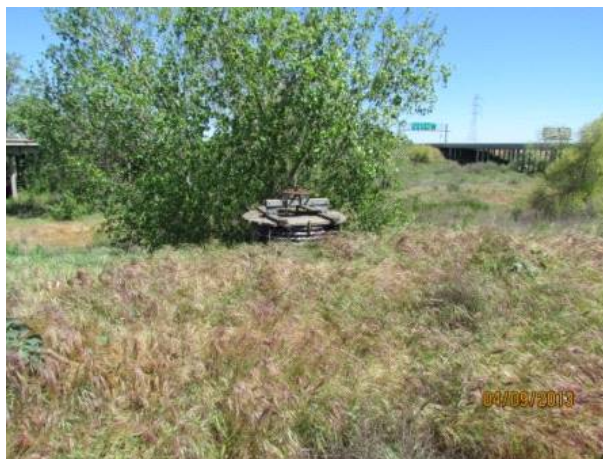
Levee Mile Report Line	6
Start Levee Mile	0.07
End Levee Mile	0.07
Location	Water Side
Category	
Item	Encroachments

View of the pipe at waterside levee hinge.

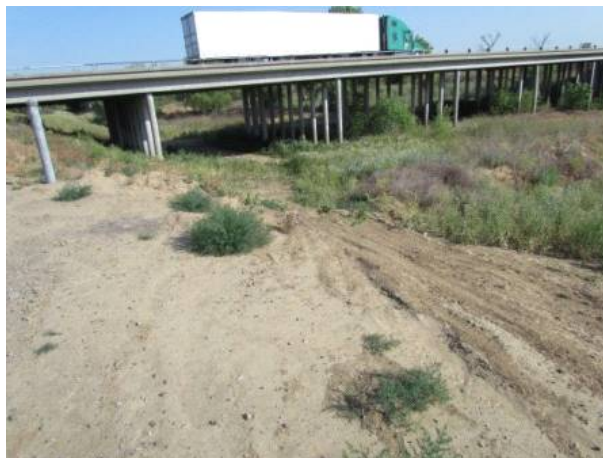
Levee Mile Report Line	7
Start Levee Mile	0.15
End Levee Mile	0.15
Location	Water Side
Category	
Item	Slope Stability

View of vehicle ruts eroding waterside slope.  
05/18/2012

En				Y
DWR ID: DWR_RD2095_01_s_2013_3										
7	0.15	0.15		Slope Stability	WS	M	S3 : Repair the levee slope damaged by vehicle traffic and prevent access where possible.	37.769977 ° -121.325012 °	37.769977 ° -121.325012 °	32
						Ma				Y
DWR ID: DWR_RD2095_01_s_2012_32										
8	0.19	0.19		Vegetation	WS	M	V2 : Remove the wild growth other than native grasses from the levee slopes. Inspector Comments: Remove pile of tumbleweeds from levee toe.	37.769643 ° -121.324363 °	37.769643 ° -121.324363 °	7
						Ma				
DWR ID: DWR_RD2095_01_f_2012_7										
9	0.31	0.31		Slope Stability	WS	M	S3 : Repair the levee slope damaged by vehicle traffic and prevent access where possible.	37.768344 ° -121.323114 °	37.768344 ° -121.323114 °	12
						Ma				Y
DWR ID: DWR_RD2095_01_s_2013_12										
10	0.35	0.35		Encroachments	CRA/W	PI : Pipe	Inspector Comments: No closure devices or flap gate on discharge pipe. Pipe penetrates freeboard of levee.	37.767822 ° -121.322835 °	37.767822 ° -121.322835 °	5

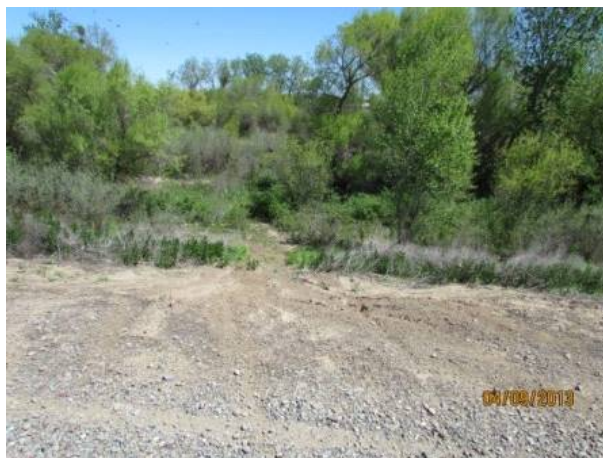
Levee Mile Report Line	9
Start Levee Mile	0.31
End Levee Mile	0.31
Location	Water Side
Category	
Item	Slope Stability

View of the vehicle tracks on waterside levee slope.

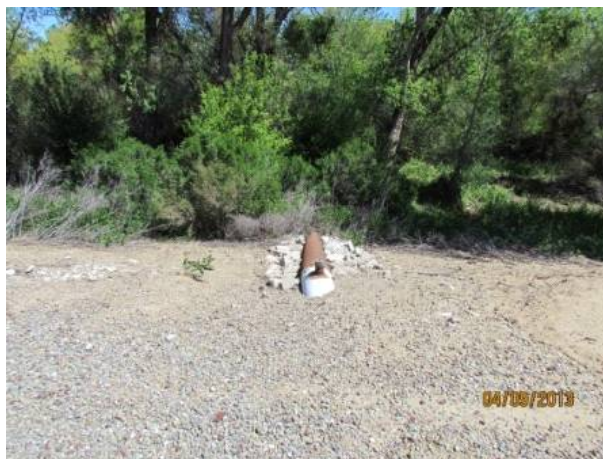
Levee Mile Report Line	10
Start Levee Mile	0.35
End Levee Mile	0.35
Location	Crown
Category	
Item	Encroachments

View of the pipe penetrating waterside levee slope.

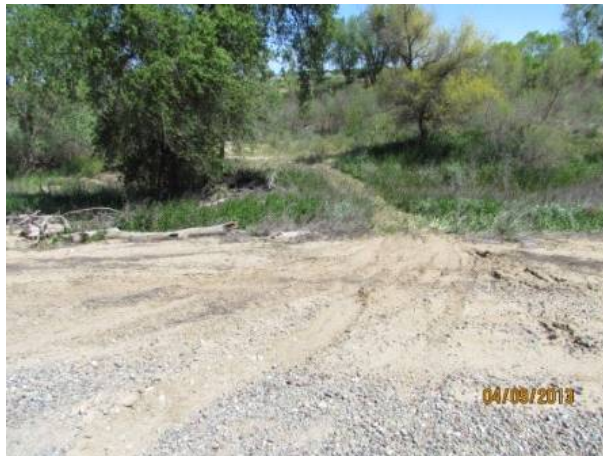
Levee Mile Report Line	12
Start Levee Mile	0.42
End Levee Mile	0.42
Location	Water Side
Category	
Item	Slope Stability

View of the vehicle ruts on waterside levee slope.

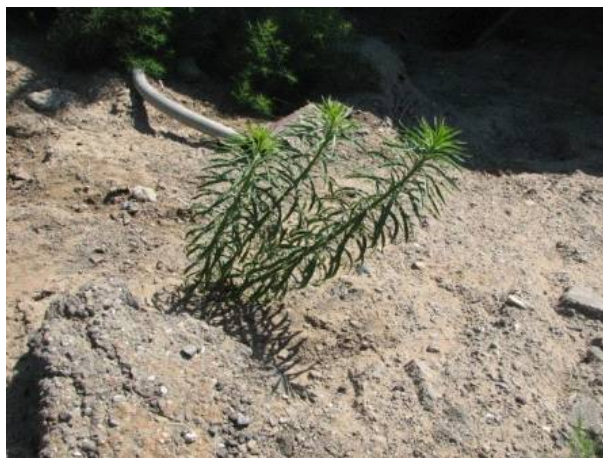
Levee Mile Report Line	15
Start Levee Mile	0.73
End Levee Mile	0.74
Location	Water Side
Category	Supplemental
Item	DWR Erosion Survey

15	0.73	0.74	Supplemental DWR Erosion Survey	WS	M	Inspector Comments: 07/18/2012: No significant changes observed on site. 09/02/2011: No significant changes observed on site. 09/22/2010: No significant changes observed on site. There is now considerable vegetation at the water line and along the lower berm slope. However, the erosion on the lower berm slope is still present and has not been corrected. 08/06/2010: Recommended for local maintenance issue, per CLRO. 07/29/2009: No major change since last visit; noticeable vegetation growth; erosion is on berm, but if left untreated, it will eventually erode into levee prism; site is recommended for annual assessment and monitoring of site, per CLRO CES 2008 Report; Site # is the same as RM6.80,LM0.73; previously rated "U". 07/22/2008: Downstream of WPRR near siphon pipe & pump; sandy levee; visited by Jeff Van Gilder and LRO in 2008 for repair assessment; scouring downstream of RxR crossing, possibly caused by eddy effects. 03/13/2007: Site visited on 03/13/2007. [2012 Site ID:RD2095U01RM6.74]	37.763630 ° -121.319000 °	37.763630 ° -121.319000 °	1 Y

Direct view of the erosion at the downstream of RR bridge.

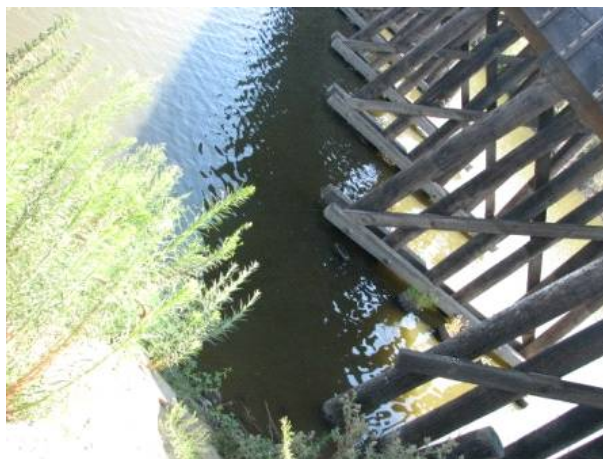
Levee Mile Report Line	15
Start Levee Mile	0.73
End Levee Mile	0.74
Location	Water Side
Category	Supplemental
Item	DWR Erosion Survey

looking up at the erosion from the lower levee slope

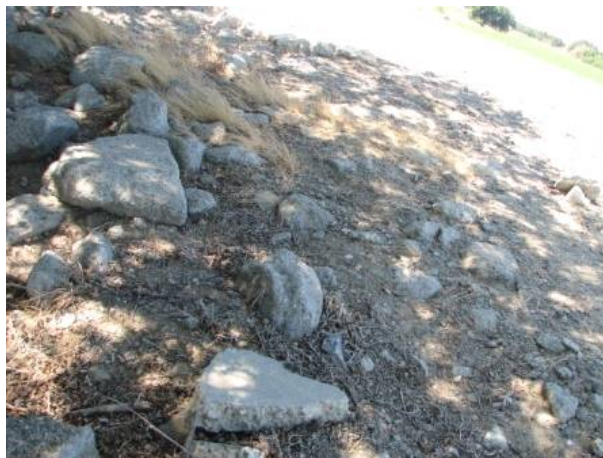
Levee Mile Report Line	16
Start Levee Mile	0.86
End Levee Mile	0.86
Location	Water Side
Category	Supplemental
Item	DWR Erosion Survey

16	0.86	0.86	Supplemental DWR Erosion Survey	WS	U	Inspector Comments: 07/18/2012: No significant changes observed. 09/02/2011: No significant changes observed. 09/22/2010: No significant changes observed. Sloughing of the existing rip rap possibly due to a combination of steep slope and undesirable flood conditions. 08/06/2010: Recommended as local maintenance issue, per CLRO. 07/29/2009: No major change observed since last visit; near-vertical slope that has rip rap sloughing; site is recommended as a local maintenance issue, per CLRO CES Evaluation 2008 Report; Site # is the same as RM6.90,LM0.86; previously rated "U". 07/22/2008: Previous erosion site that is partially protected with concrete rubble; erosion scarp is adjacent to the sloughing rip rap. 03/13/2007: Site visited on 03/13/2007. [2012 Site ID:RD2095U01RM6.88]	37.761960 ° -121.318140 °	37.761960 ° -121.318140 °	2 Y	
							DWR ID: DWR_RD2095_01_s_2013_2

Direct view of the site

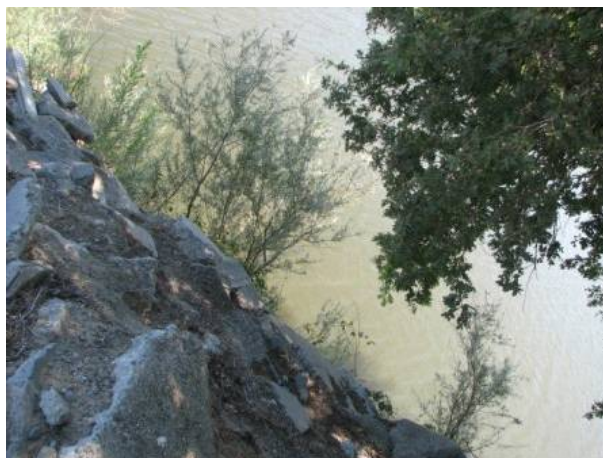
Levee Mile Report Line	16
Start Levee Mile	0.86
End Levee Mile	0.86
Location	Water Side
Category	Supplemental
Item	DWR Erosion Survey

Direct view of the site

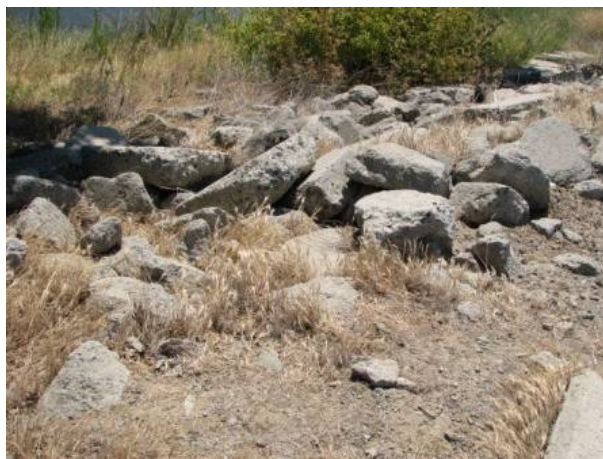
Levee Mile Report Line	16
Start Levee Mile	0.86
End Levee Mile	0.86
Location	Water Side
Category	Supplemental
Item	DWR Erosion Survey

Direct view of the site

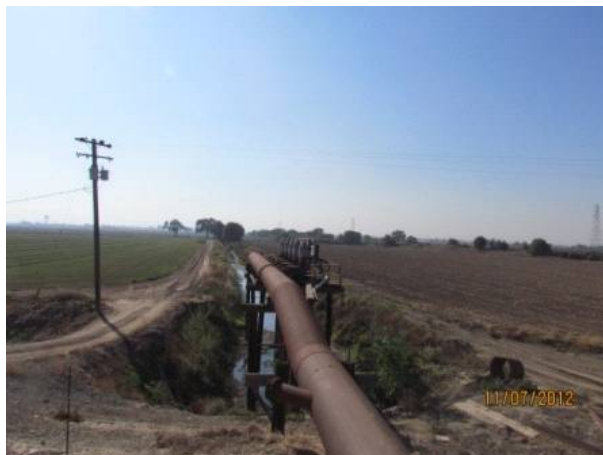
Levee Mile Report Line	17
Start Levee Mile	0.87
End Levee Mile	0.87
Location	Land Side
Category	
Item	Encroachments

17	0.87	0.87	Encroachments	LS A/W	PI	PI : Pipe Inspector Comments: Large pump platform for drainage into San Joaquin River. Three pumps. No positive closure devices. Pipe penetrates levee freeboard. No flap gate at outlet.	37.761472 ° -121.317840 °	37.761472 ° -121.317840 °	15 Y	
							DWR ID: DWR_RD2095_01_s_2012_15

View of the pumps on landside.

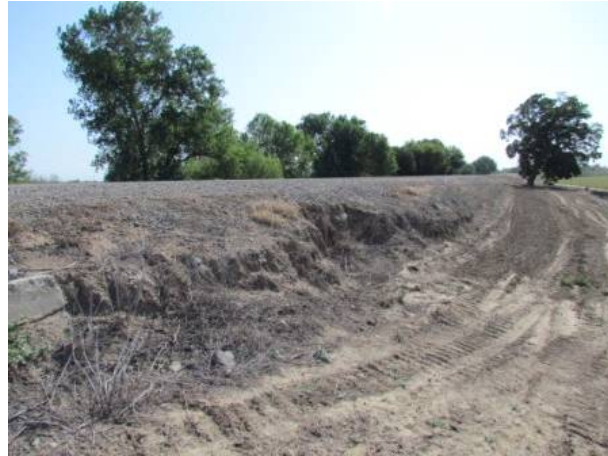
Levee Mile Report Line	21
Start Levee Mile	1.17
End Levee Mile	1.17
Location	Land Side
Category	
Item	Slope Stability

View of erosion site on landside slope. 05/18/2012

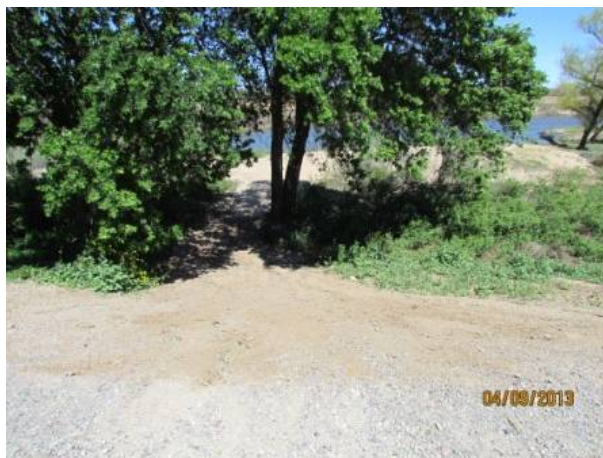
View of the vehicle tire ruts on waterside levee slope.

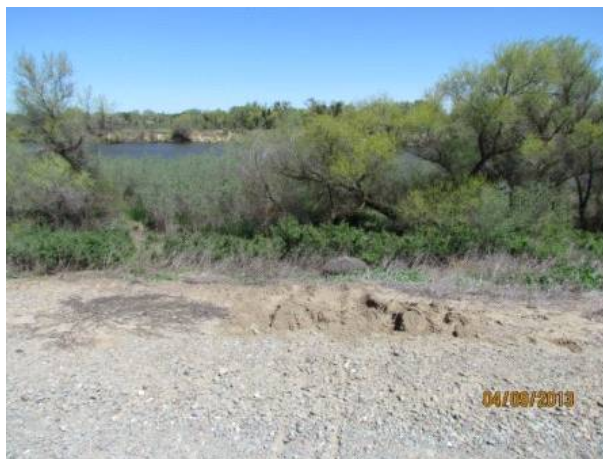
Levee Mile Report Line	2
Start Levee Mile	0.18
End Levee Mile	0.18
Location	Water Side
Category	
Item	Slope Stability

View of the vehicle tire ruts on waterside levee slope.

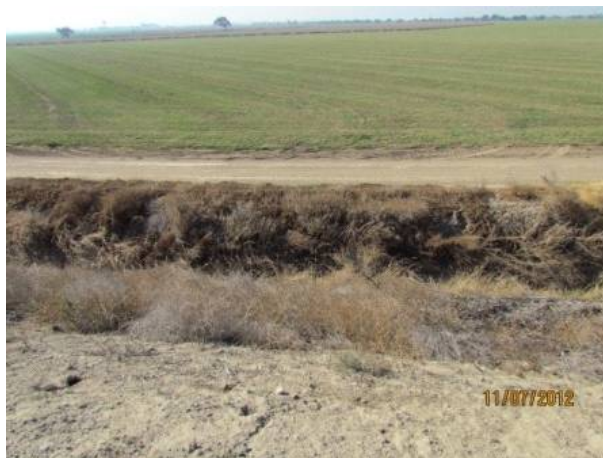
Levee Mile Report Line	3
Start Levee Mile	0.36
End Levee Mile	0.85
Location	Land Side
Category	
Item	Encroachments

View of ditch along landside toe.

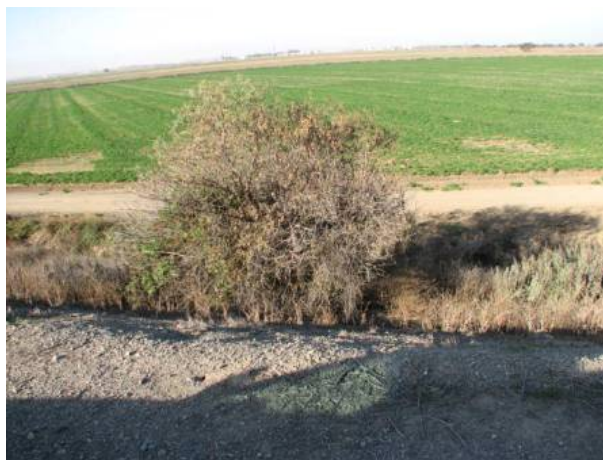
Levee Mile Report Line	5
Start Levee Mile	0.62
End Levee Mile	0.62
Location	Land Side
Category	
Item	Vegetation
11/01/2011 Elderberry bush at landside toe.	
mkhashch_s_20130225_586.jpg

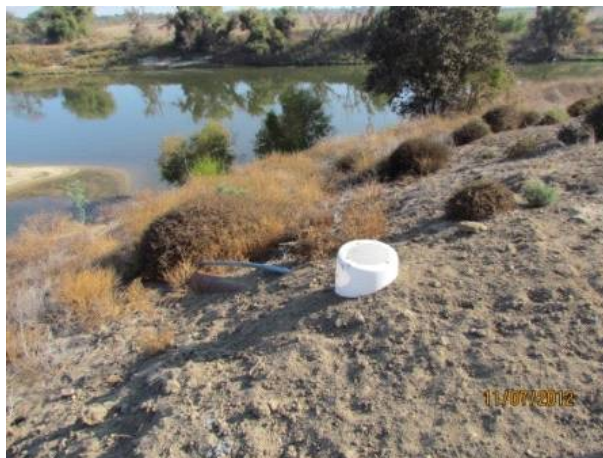
Levee Mile Report Line	13
Start Levee Mile	1.67
End Levee Mile	1.67
Location	Crown
Category	
Item	Encroachments
View of corrected slope erosion. Siphon breaker valve is covered by bucket with drain pipe diverting water away from slope.	
mkhashch_s_20130225_587.JPG

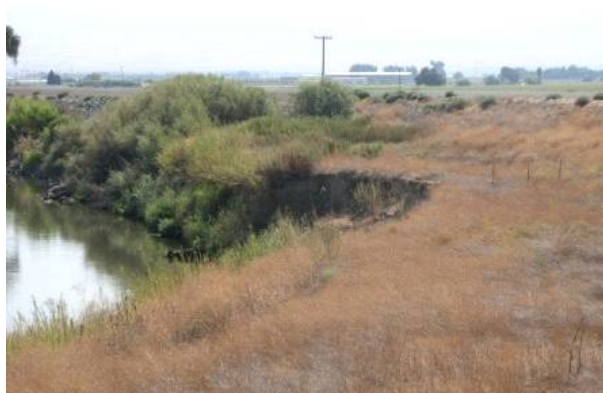
Looking upstream of the site. Note dense vegetation on the berm.

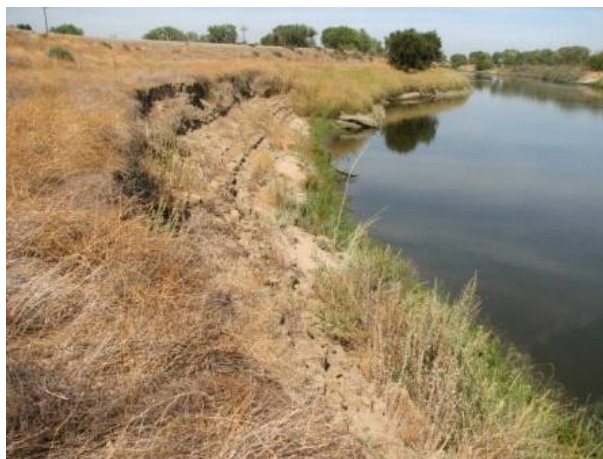
Levee Mile Report Line	14
Start Levee Mile	1.77
End Levee Mile	1.80
Location	Water Side
Category	Supplemental
Item	DWR Erosion Survey

14	1.77	1.80	Supplemental	DWR Erosion Survey	WS	M Ma	Inspector Comments: 09/13/2012: The site has been visited by land survey. The vegetation on the site shows the erosion has not developed significantly from the last survey. The site was not visited by boat survey due to the limitation of navigatable waterway. 08/23/2011: No significant changes observed on the site. 9/22/2010: No significant changes observed on site. There is moderate vegetation growth on the berm. Despite the erosion occurring on the berm, corrective action should be taken before the issue becomes severe. 9/29/2009: Site is immediately downstream of a section of existing rip rap; there is a 20-foot berm remaining; berm will continue to erode unless erosion is mitigated; Site# is the same as RM62.6, LM1.87; recommended for annual assessment, per CES Evaluation 2008 Report 2006: Visited 10/20/06 [2012 Site ID:RD2095U02RM60.62]	37.740196 ° -121.297662 °	37.740196 ° -121.297662 °	1 Y

Looking downstream of the site.

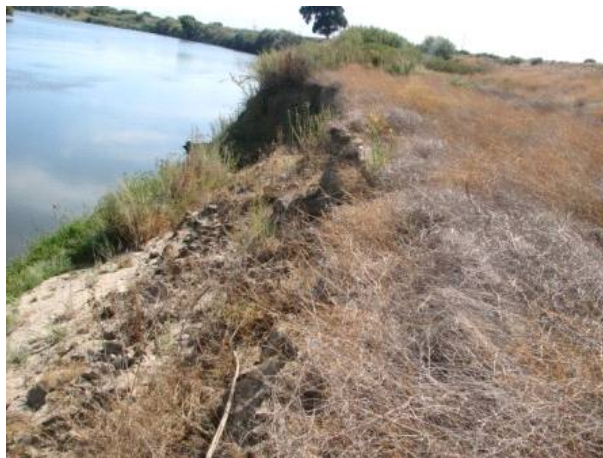
Levee Mile Report Line	14
Start Levee Mile	1.77
End Levee Mile	1.80
Location	Water Side
Category	Supplemental
Item	DWR Erosion Survey

Close view of the site.

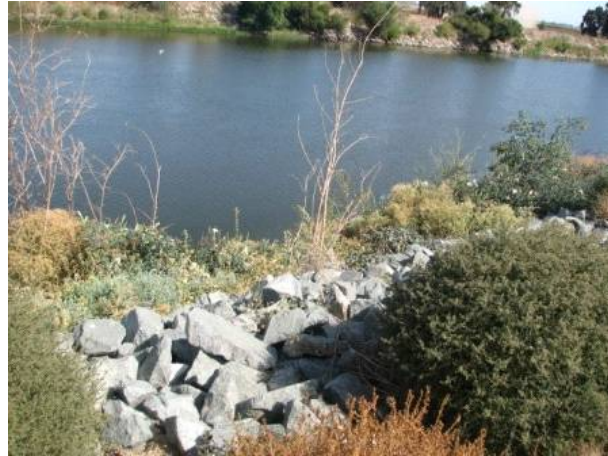
15	1.85	1.89	Supplemental	DWR Erosion Survey	WS	M Ma	Inspector Comments: 09/13/2012: The site has been visited by land survey. The erosion is not visible from the levee slope because of dense vegetation at the site. Levee slope is protected by placed rocks. The site was not visited by boat survey due to the limitation of navigatable waterway. 08/23/2011: Dense vegetation makes it difficult to view the possible erosion. No new development was observed on site. 09/23/2010: At the time of the inspection, the erosion site was difficult to view from the levee. Erosion is located on the bank toe, below the existing rip rap. There were no signs of repair on site, nor has the site been reported to be repaired by the district. Images taken from last year indicate that existing rip rap at the bank toe has sloughed exposing the underlaying soils. Weakening of the toe could lead to future bank instability. 08/05/2010: Recommended for annual assessment and monitoring during flood events, per CLRO. 09/29/2009: No major change observed since last visit; sloughing of the rip rap above toe; erosion begins immediately downstream of existing rip rap revetment; roughly 15-foot berm remains; however, it will continue to erode and eventually intrude into the levee profile if left untreated. 10/20/2006: Just upstream of where berm starts to widen. [2012 Site ID:RD2095U02RM60.69]	37.738880 ° -121.298260 °	37.738880 ° -121.298260 °	2 Y

View from levee slope. The dense vegetation on the site block the view of the erosion

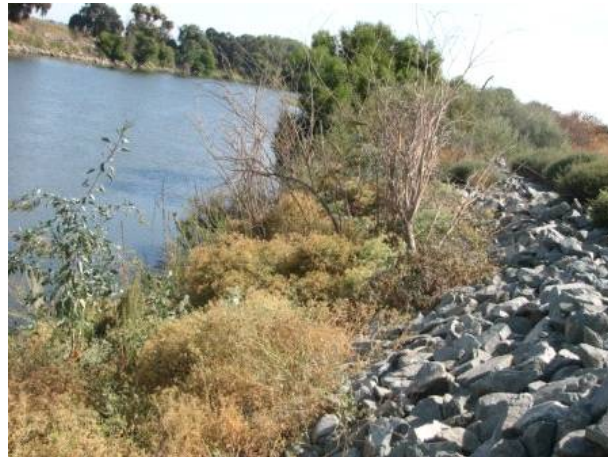
Levee Mile Report Line	15
Start Levee Mile	1.85
End Levee Mile	1.89
Location	Water Side
Category	Supplemental
Item	DWR Erosion Survey

Front view of the erosion.
